Manhole Inspection Summary

Manhole # S15EE1010MH

Location Address: **3821 DERBY MANOR DR**

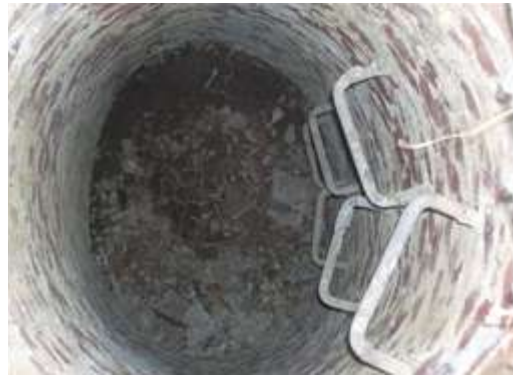
Top View

Channel debris.

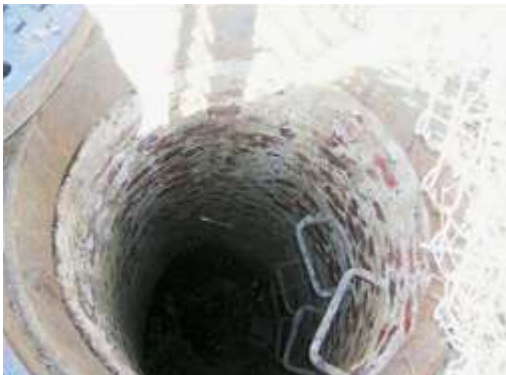
Defect

☒ **Leaks**

Condition: ☐ Sound ☐ Cracked ☐ Root Intrusion ☐ Loose Brick ☒ **Deteriorated**

Infiltration: ☐ None ☒ **Joint** ☐ Cracks ☒ **Mortar** ☐ Roots ☐ Wall

Frame leaks. Adjustment deterioration and infiltration - other side.

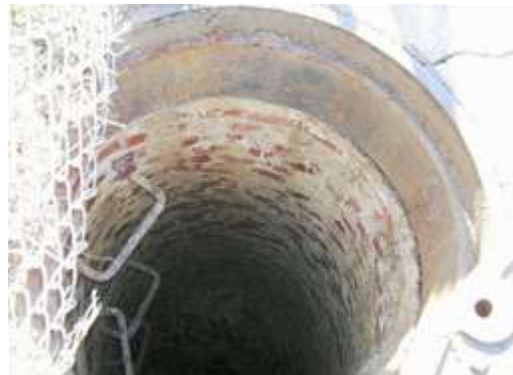
Defect

Frame leaks. Adjustment deterioration and infiltration.

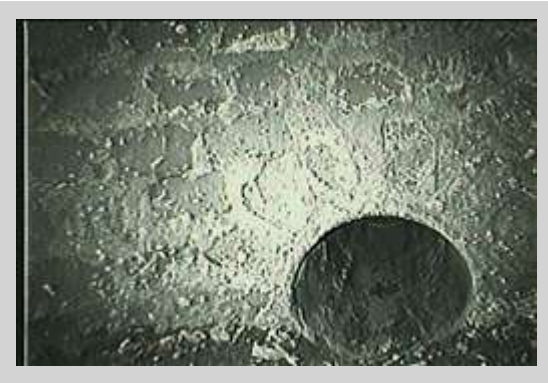
Condition: ☐ Sound ☐ Cracked ☐ Root Intrusion ☐ Loose Brick ☒ **Deteriorated**

Infiltration: ☐ None ☐ Joint ☐ Cracks ☒ **Mortar** ☐ Roots ☐ Wall

Barrel deterioration and infiltration.
